M. Yankelevich

The design–built company “PARSONS”, New York, USA

**FROM MY EXPERIENCE IN USA.
THE FORMER TERMINAL A IN AIRPORT “LOGAN”**

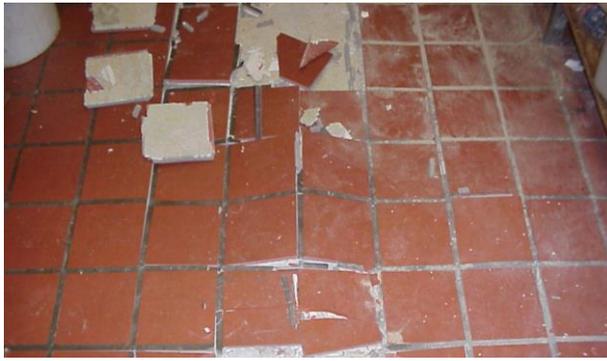
However, the most critical was the corner slab that was not continuous on two corner exterior sides of the building. On one of the upper floors the popped up tiles were also found out in the closed at the most of time storage room located at the corner slab (Fig. 6).

The elastic analysis of waffle slab was performed using the model that included four slab units on 9 columns below and above in which interior sides were moment restrained (continuous) and exterior sides between the columns were free. The results of analysis showed that the span positive moment in the critical span section of the corner slab was about 30% larger than the moment capacity of the critical section.

Based on such results, we performed the yield line analysis of this slab calculating the moment capacity of sections using f_{ps} - stress in prestressed tendons at nominal strength [2] and project specified stresses of concrete. The load bearing capacity of the slab based on this analysis was equal of: $P_{limit} = 0.365$ ksf. The service load on the airport slab included 0.138 ksf dead load and 0.1 ksf live load – 0.238 ksf total load. The safety factor obtained was equal of $SF = 1.53$, which was 8% smaller than minimal safety factor that would be provided by the load factor design:

Fig.6. Popped Tiles on Corner Slab

- The crack width gages were installed on cracks at several slab ribs (Fig. 7) and the crack width monthly monitoring were performed during 6 month period.
- Monthly survey was performed on random bays of floors to monitor the deflections variation during 6 month period too.
- Observations were made to figure out the real maximum live loads on the floors.

Since the cracks width and the deflections during the half year observation had not been increased and the observed load was much less than the design load, we concluded that the airport building could stay in temporary service.

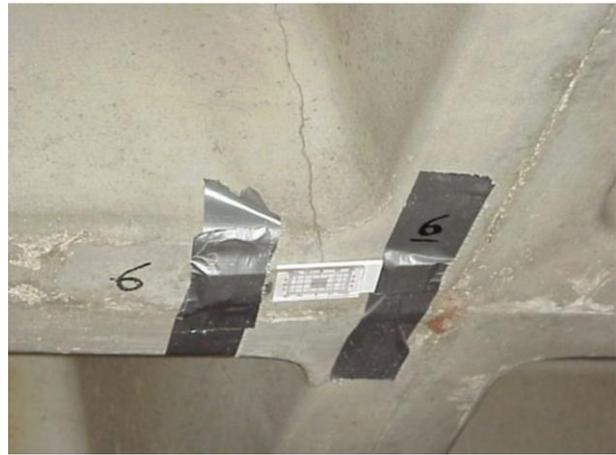
Fig.7. Monitor on the Crack on the Waffle Slab Rib

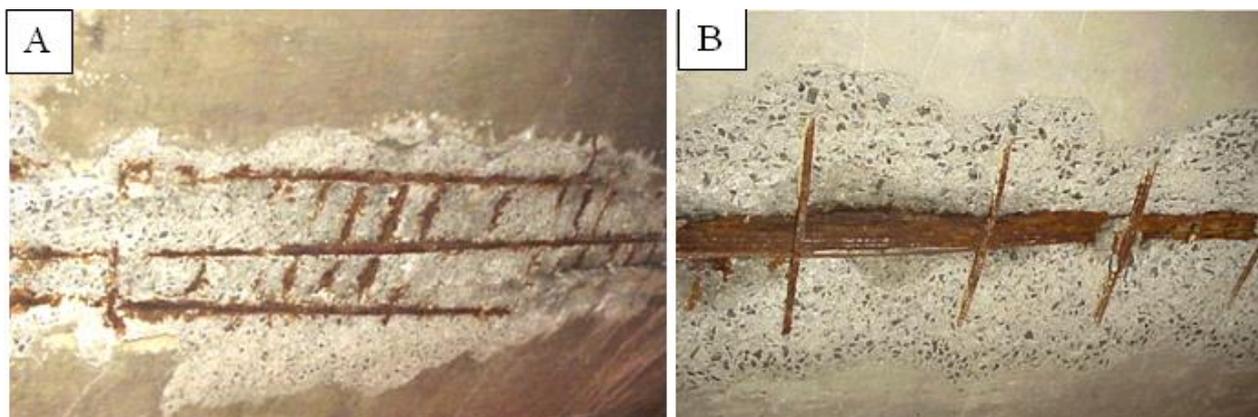
The observations of ramps showed that in several places the both ramp slabs had deterioration of concrete with open reinforcement covered with rust (Fig. 8). It should be noted that these ramp slabs are actually 8" ($\approx 200\text{mm}$.) thick one way slabs with 16 ft ($\approx 5\text{m}$.) span restrained on both sides in circular 1 foot ($\approx 30\text{mm}$.) thick walls and in such arrangement restricted not only from rotation but also from horizontal movement.

The investigations of such slabs [3, 4, 5] show that their capacity drastically increases due to outward trust. Our calculations, performed using the algorithm that was developed in NIISK (Kiev) for program "RASPOR" [5], showed that the use of prestressed reinforcement in such slabs was too redundant and the required capacity was achieved even if the amount of reinforcement was 75% lesser than what was used in the original design.

Fig. 8. Deteriorated Concrete and Rusted Reinforcement at the Bottom of Ramp Slabs:
A – East Ramp; B – West Ramp

Based on above, it was recommended to use rust remover and to clean rust at the exposed reinforcement and apply protecting paint. After this temporary use of ramps for the term required was allowed.

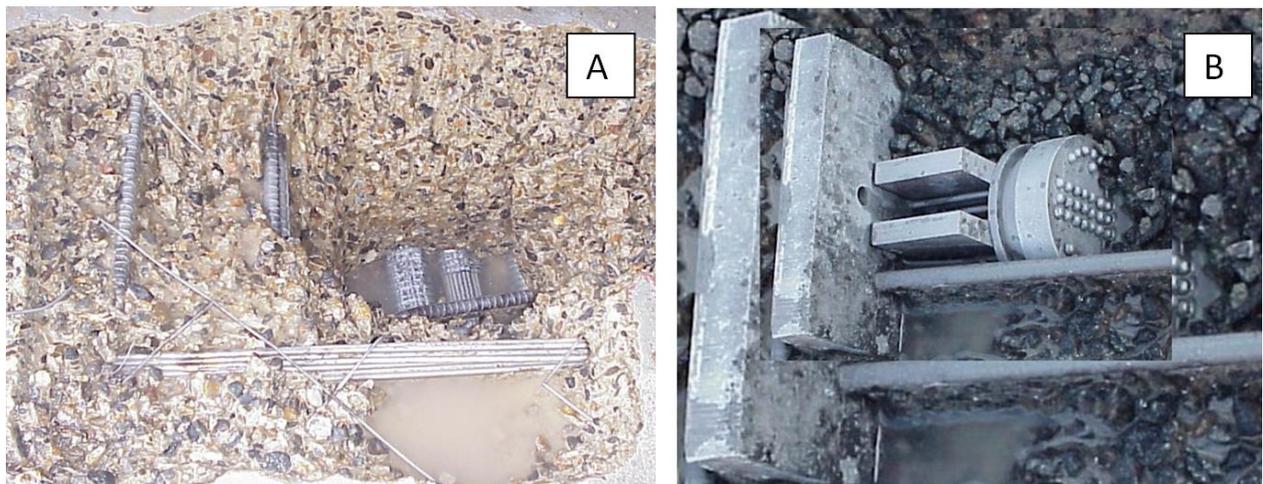
High pressure hydraulic demolition procedure was used for concrete chipping and exposing the tendons and anchors. As it is shown on Fig. 9 the anchors and the slab reinforcing at the roof corner were in good condition. There was an option to re-anchor these tendons that should stay in place before start of slab partial demolition.

Fig. 9. Open Reinforcing (A) and Anchor (B) after Concrete Chipping

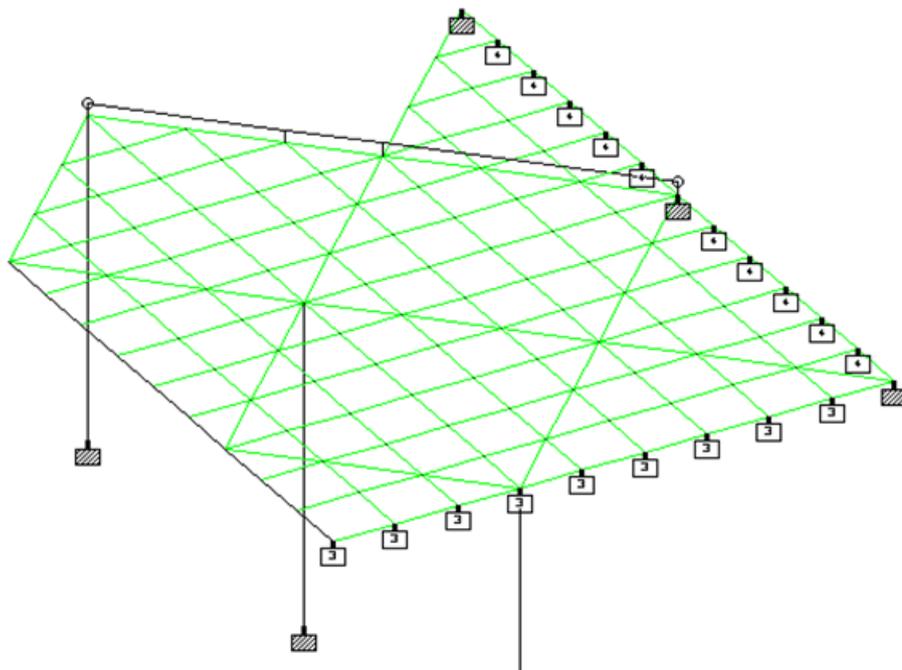
Fig.10. Model of Roof Corner after Cantilever Demolition for Analysis with Program STAAD.

After the demolition at cantilever corner the middle-span moment at the next span of the roof rib supported by the corner column would increase. The decision was to add the steel beam above and connect it with hangers to the rib, as it is shown on the design model (Fig. 10). Such way the capacity of the partially demolished roof was warranted.
