M. Yankelevich

The design–built company “PARSONS”, New York, USA

**FROM MY EXPERIENCE IN USA.
THE FORMER TERMINAL A IN AIRPORT “LOGAN”**

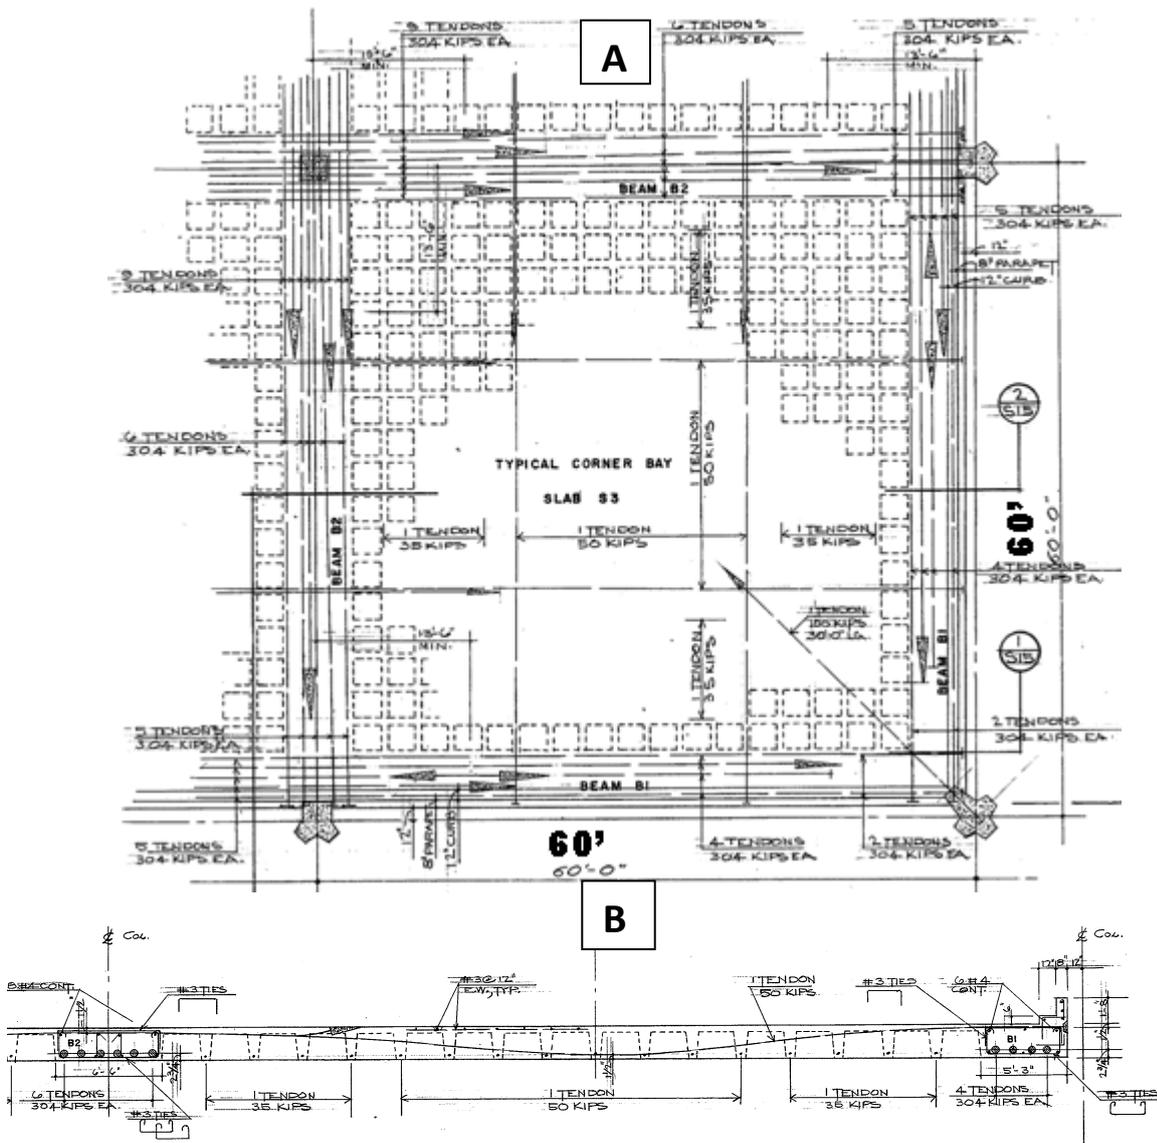
Fig.5. Plan (A) and Section (B) of a Corner Waffle Slab

waffle slabs (Fig. 5) located at each of the columns rows were modeled and calculation was performed using STAAD software.

Checking the concrete sections under the factored designed forces we revealed that the outer columns connections to the girds at the first three levels had the moments that were up to 15% larger than the capacity of sections while the forces in the joints at middle columns and girds sections were more than 50% smaller than the capacity of their sections. Inspection of the structures was performed and revealed that the edge columns had visual cracks. No cracks were found in interior sections. It was decided to place at the design model plastic hinges in connection of girds to the outer columns and applies in hinges the moments corresponding to the minimum moment capacity of columns or girds. Reviewing the forces in all critical sections obtained by this analysis under all design load combinations we found out that the load capacity of frame was in the allowable limits. Based on this and taking into account the 30 years of framing service we made a positive conclusion on the results of Wind Vulnerability Study.

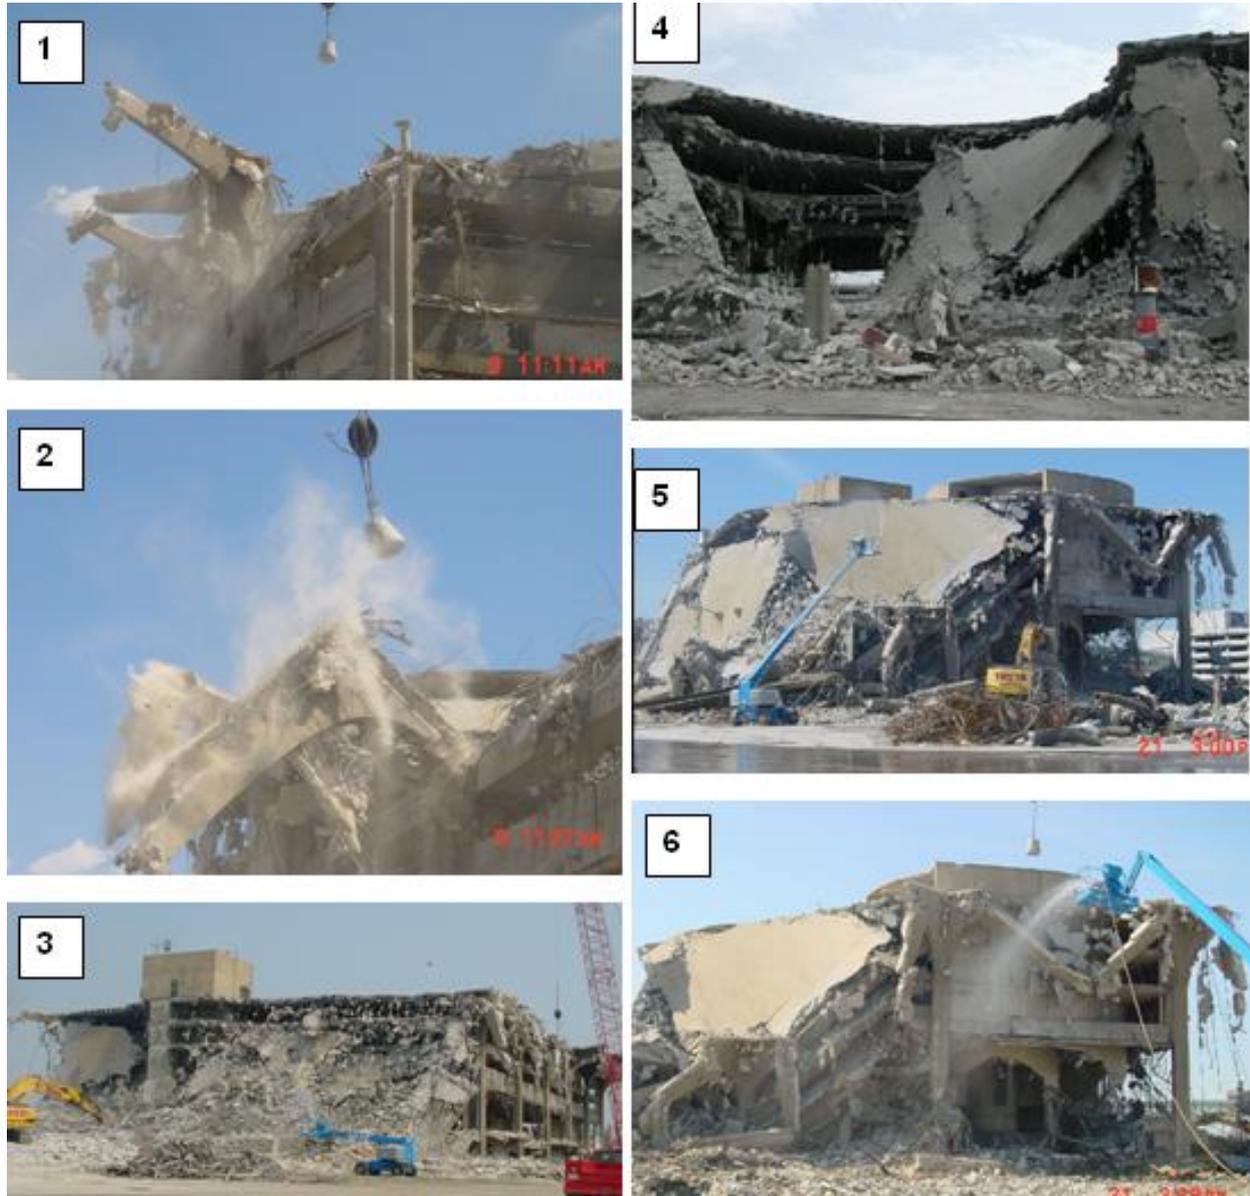
Fig. 11. Phases of Demolition (sequence follows the numbers)

concrete structure was a very complex task. The demolition project was developed and coordinated with an experienced demolition company who performed the demolition. One of my tasks was to visit the demolition site from time to time and to control the demolition process. The photos that I made during my visits are presented on Fig. 11. The demolition mostly performed by using crane boom swing with a heavy weight hanging ball.

The procedure took place with permanent water streaming around the each particular demolition place to avoid dust and small debris to fly around the airport area. The demolition was performed approximately during a month period and finally was completed in August 2002.
